Technical Report HL-94-1  
May 1995

# **Demonstration Erosion Control Project Monitoring Program**

## **Fiscal Year 1993 Report**

### **Volume I: Main Text**

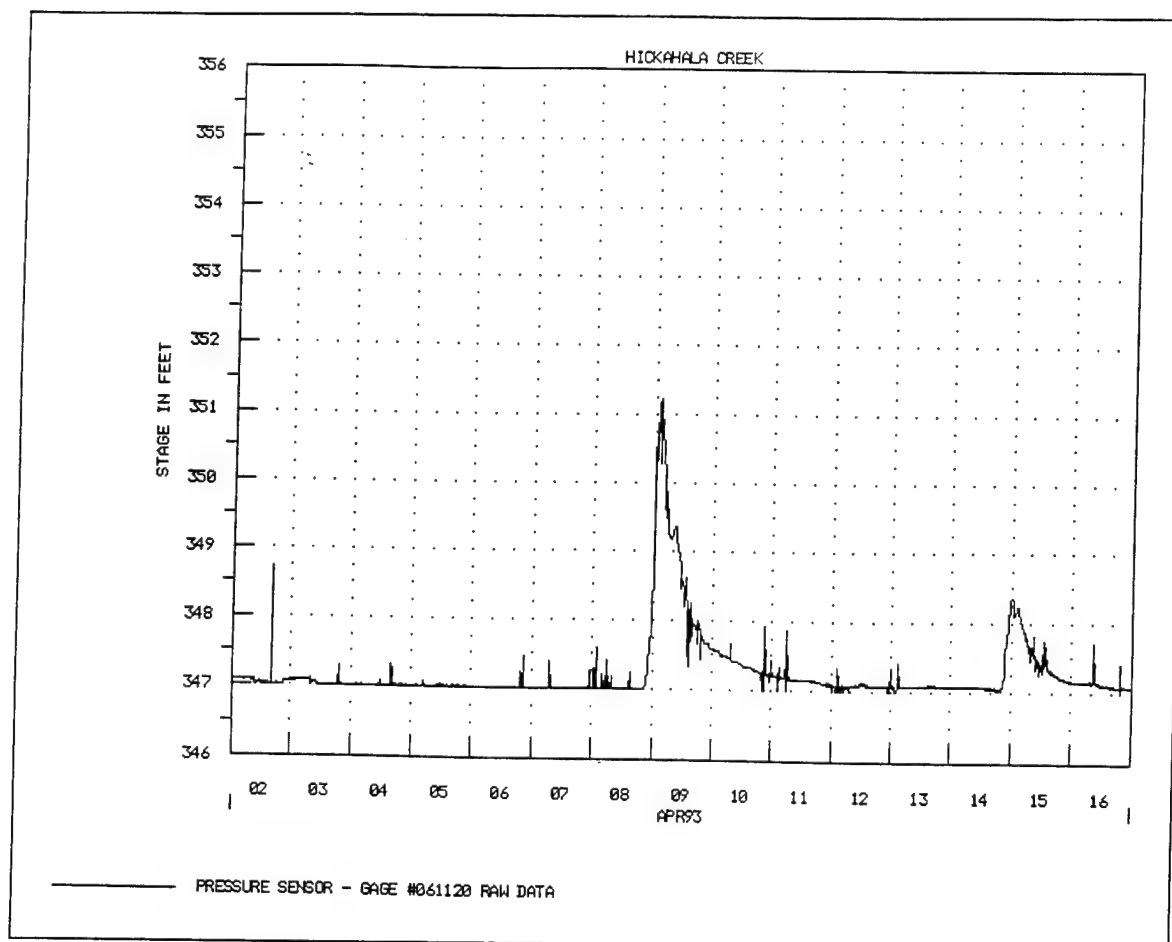
Figure 2. Pressure transducer data with spikes

When small amounts of data were initially graphed, many fluctuations due to temperature and large spikes of uncertain origin were noticed. For the Stevens transducers the spikes were generally not more than 1 to 1-1/2 ft,<sup>1</sup> while for the ultrasonic sensors, they varied from 0.5 ft to the instrument's maximum range. The cause for the anomalous readings from the pressure transducers has not been ascertained. The causes for the anomalous readings from the ultrasonic instruments have been found to be due to any of various circumstances, some of which are no water in the creek, insect nests in the wave guide, birds flying under the instrument, and damaged or malfunctioning pulse emitters. An example of data from a pressure transducer assembly that produced unwanted and unidentified spikes is shown in Figure 2. Data from an ultrasonic data collection assembly that includes various spikes and spurious data are shown in Figure 3.

It can be seen by viewing the raw data shown in Figures 2 and 3 that, in general, the desired hydrographs of 1-ft rise and larger can be visually picked out. However, the "noise" can be distracting and also takes up much data storage space. For most purposes in the DEC monitoring project, events of less than 1 ft are not of significant interest. Therefore a spike-removal/data-averaging program was written that uses these raw data files to produce files that are much clearer and smaller. The program works by checking for changes in stage values greater than some amount that is observed to be possible in the data logging interval (10 min). The greatest observed change in stage over 10 min that was found was approximately 1.2 ft. Therefore a conservative value of 1.5 ft was selected. Thus, whenever a change in stage of more than 1.5 ft in a 10-min interval occurs, the program considers it a spike, and deletes it from the data. The inherent danger in this is that a real change greater than 1.5 ft in the interval could possibly happen. However, then a hydrograph with a missing peak would be evident. The raw data files are saved, and thus the data could be retrieved and the peak reconstructed manually.

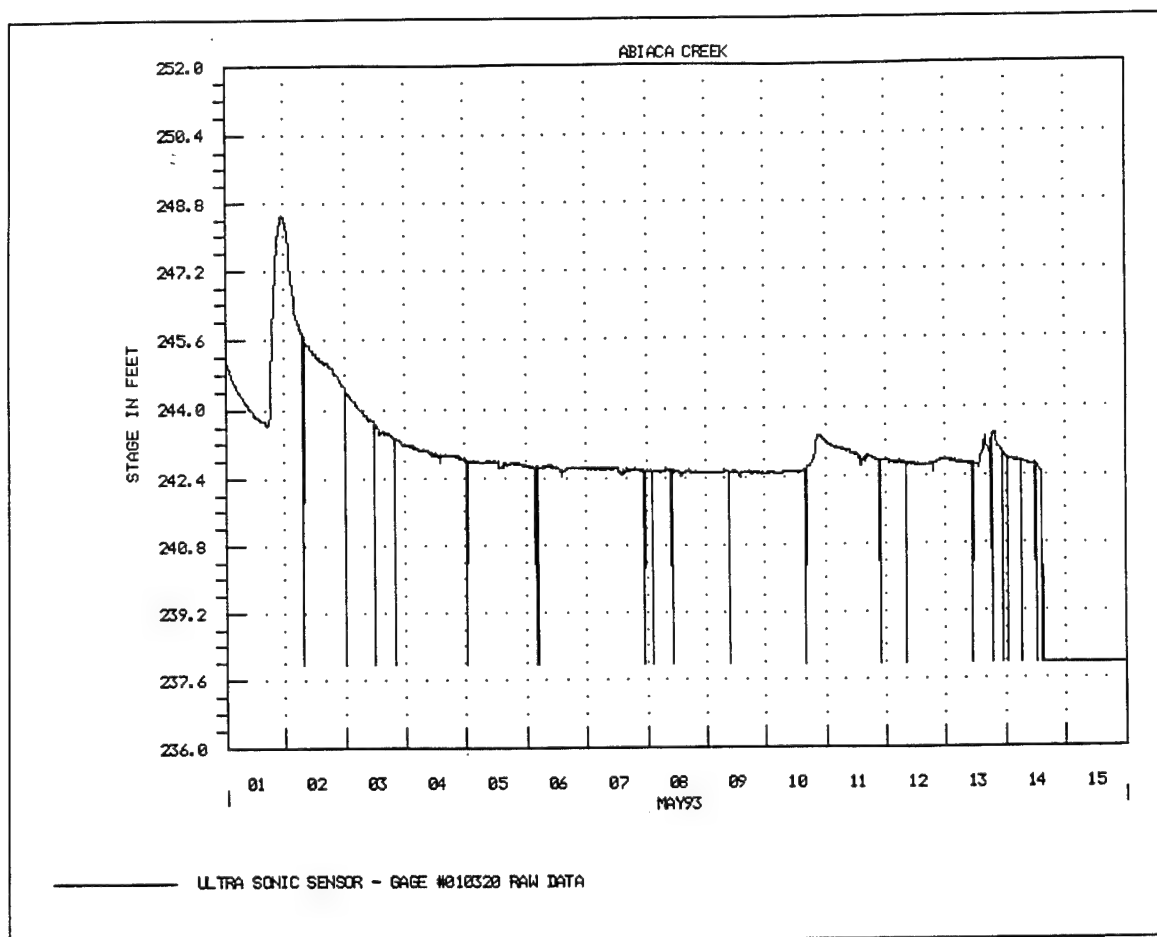
Figure 3. Ultrasonic sensor data with spikes

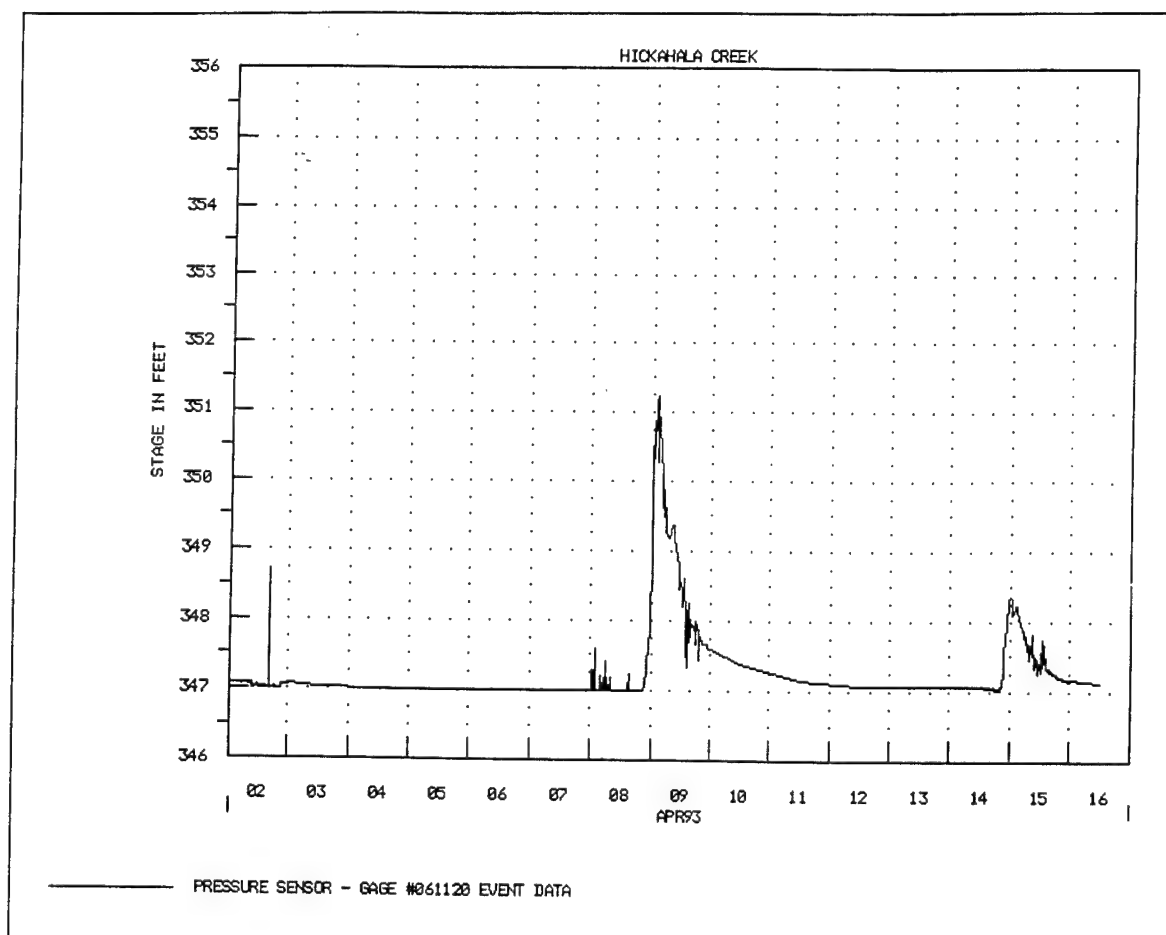
Figure 4. Reduced pressure transducer data

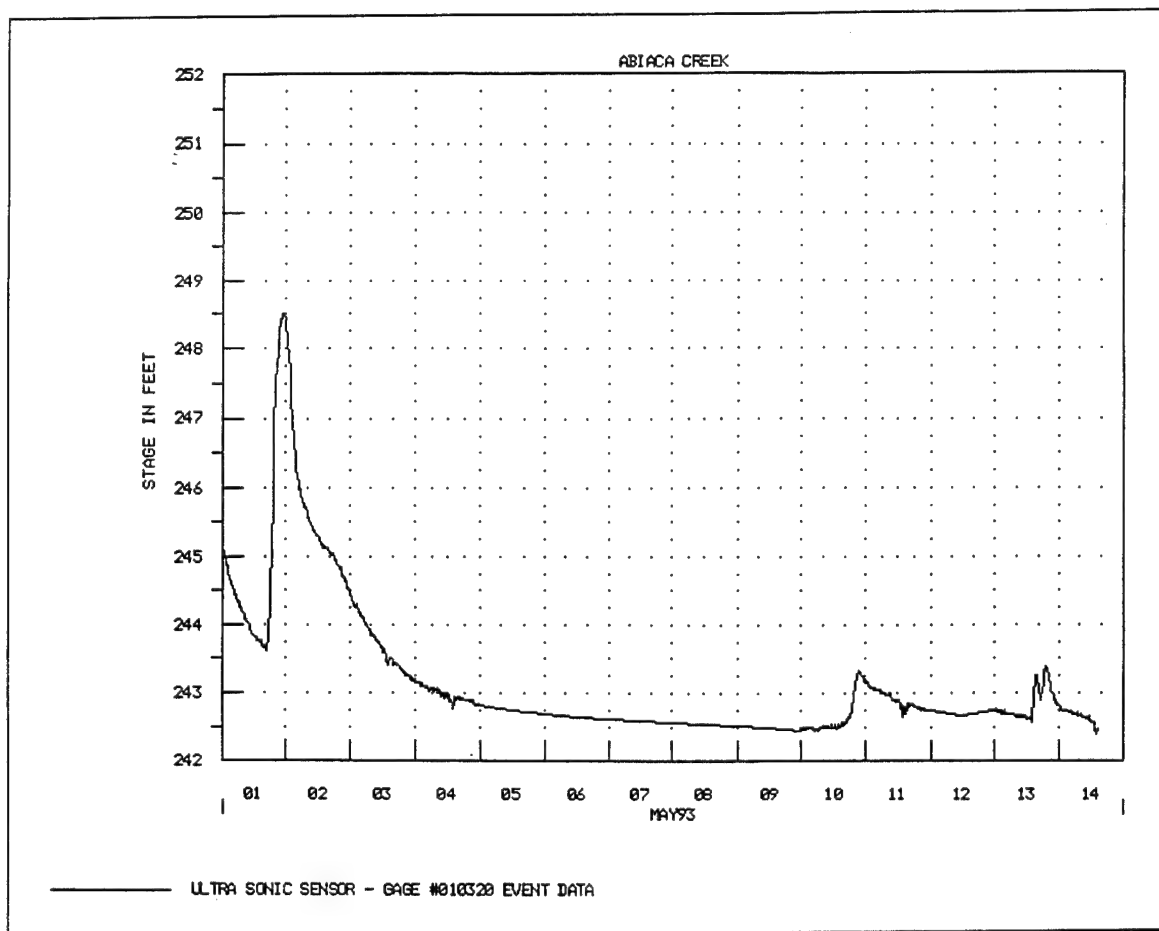
Figure 5. Reduced ultrasonic sensor data

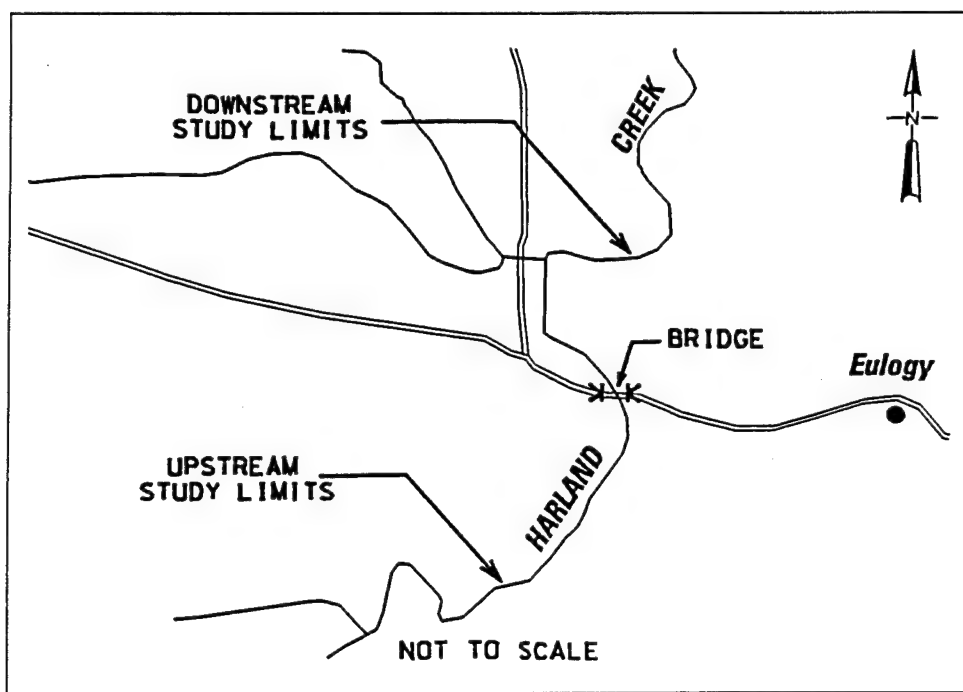
Figure 10. Harland Creek, Site 1

Site 1 is located on Harland Creek in the Black Creek watershed. The site is near Eulogy, MS, and can be found on the Lexington quadrangle map in T14N, R1E, Sections 22 and 27. Harland Creek is a mixed sand and gravel bed stream, exhibiting some of the original meandering tendency shown on the map in Figure 10. The study reach is approximately 4,000 ft in length, 2,000 ft upstream and downstream of the county road bridge. The stream is unstable, with bank erosion and significant channel widening. Several areas of massive bank failures were identified, and these failure sites, along with bed and bank erosion, provide a high sediment yield to the downstream.

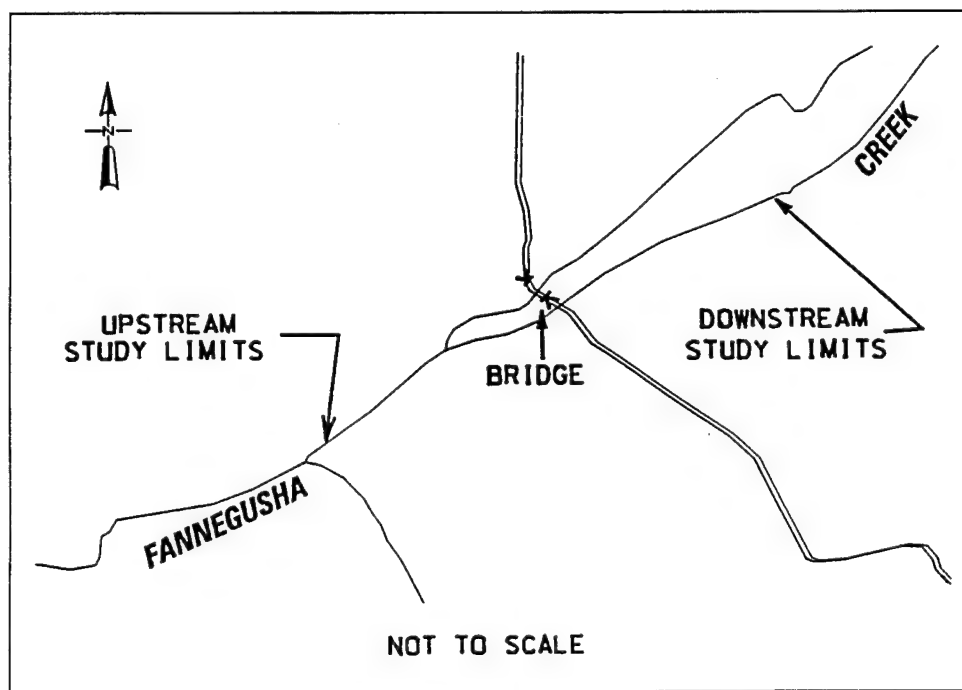
Figure 11. Fannegusha Creek, Site 2

Site 2 is located on Fannegusha Creek, also in the Black Creek watershed, and can be found on the Coila quadrangle map in T16N, R3E, Sections 1 and 2. As shown in Figure 11, the study reach is approximately 4,000 ft in length, 2,000 ft upstream and downstream of a county road bridge. Two low-drop structures are planned for the site, one immediately downstream of the bridge and the other approximately 2,000 ft downstream of the bridge. The stream is presently unstable, and it has been reported that the county bridge has been closed since January 1992 due to channel widening. Initial

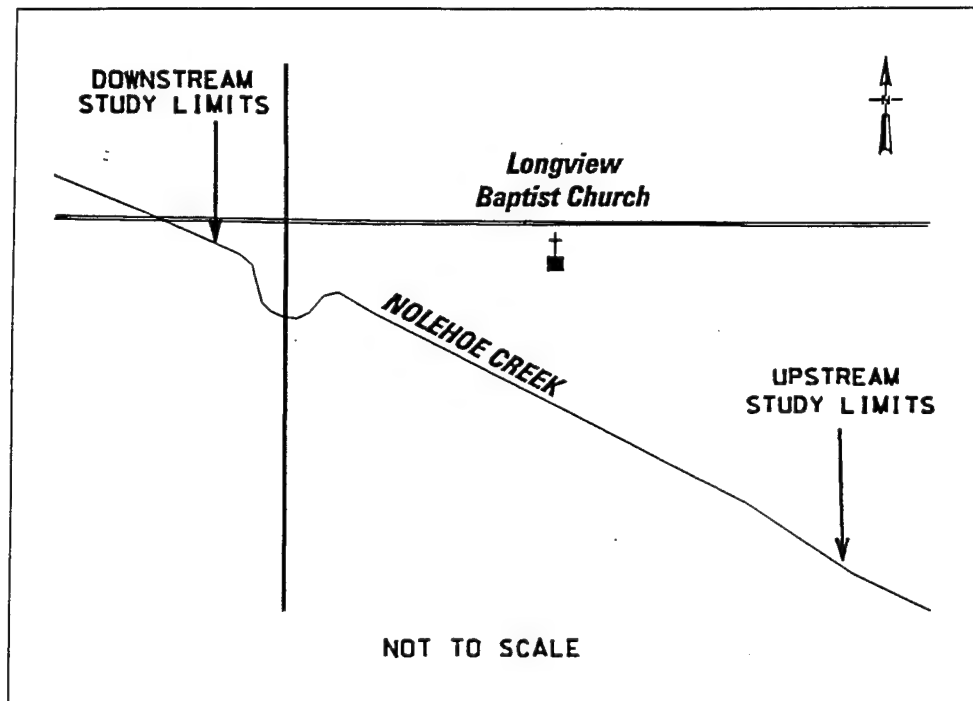
Figure 16. Nolehoe Creek, Site 7

Site 7 is located on Nolehoe Creek in the Coldwater River basin near the community of Olive Branch, MS. The site is located on the Hernando quadrangle map, T1S, R7W, Section 35, and has a drainage area of approximately 3.7 square miles. The study reach, shown in Figure 16, is approximately 4,000 ft in length, extending downstream from a box culvert. The channel is extremely unstable and is deeply incised. Bed material load ranges from sand to particles in excess of 30 mm. Two low-drop structures are planned for the reach; however, permission to construct the structures has not been received from the landowner. Stream stage recording stations have been recently installed by WES at the downstream roadway culvert.

This incising reach is between upstream and downstream box culverts, and the reach is representative of suburban development in the metro-Memphis area. An interview with a local landowner confirmed that a major cutoff of the channel had been made in the last 10 years. These conditions are typical of the result of ill-planned local development improvements, and the documentation of the resulting problems may be of value in assisting future local drainage planning.

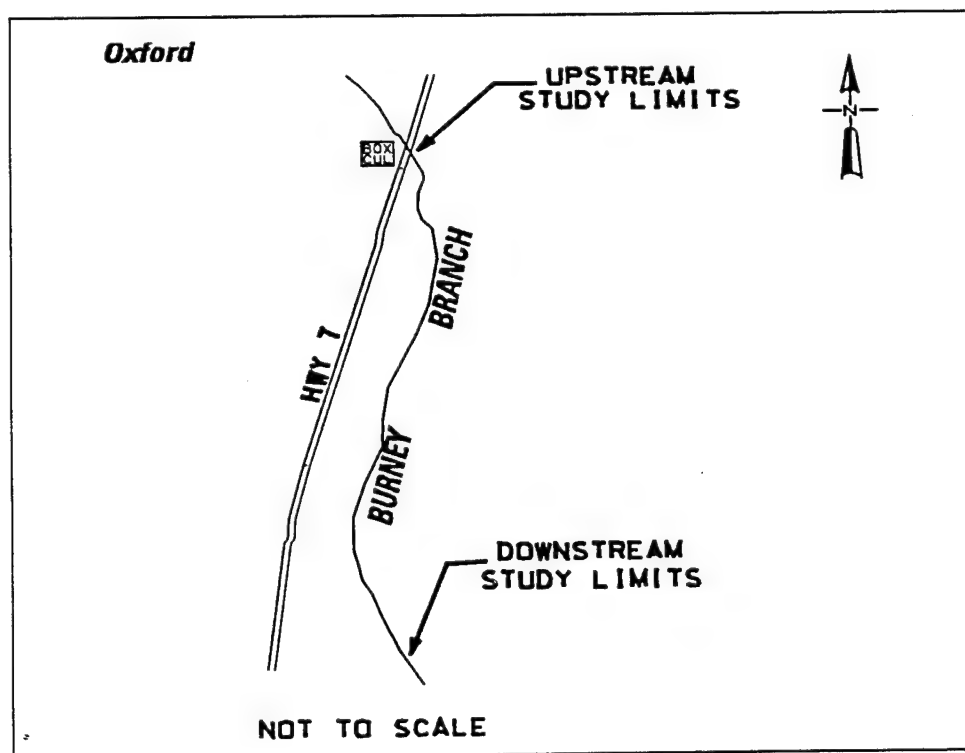
Figure 23. Burney Branch, Site 12

Site 12 (Figure 23) is located on Burney Branch near Oxford, MS. The study reach begins at the Highway 7 crossing of Burney Branch and extends downstream for a distance of approximately one mile through a reach containing two SCS high-drop structures. The drainage area of Burney Branch at this

The two high-drop structures have been very successful in rehabilitating this reach of Burney Branch. Both structures were constructed in 1982 by SCS, and the effects of the structures on the channel were surveyed and analyzed by Schumm, Harvey, and Watson (1984). These structures were designed to contain the 100-year discharge and include the provision for floodplain storage using valley dams in conjunction with each structure. The original design of the structures provided for a bed slope of 0.0008 between structures, based on Lane's tractive stress analysis. The 1984 surveyed bed slope was 0.0012, indicating that the upstream sediment yield was greater than planned. Since 1984, several major channel stabilization projects have been constructed upstream. The survey made in January 1992 will document the effects of changes since 1984 and will provide data with which to evaluate channel change as sediment supply is reduced. Channel stabilization under conditions of reducing sediment supply is a situation that will be faced as the success of the DEC programs is realized. Potentially, upstream stabilization can cause stability problems downstream.

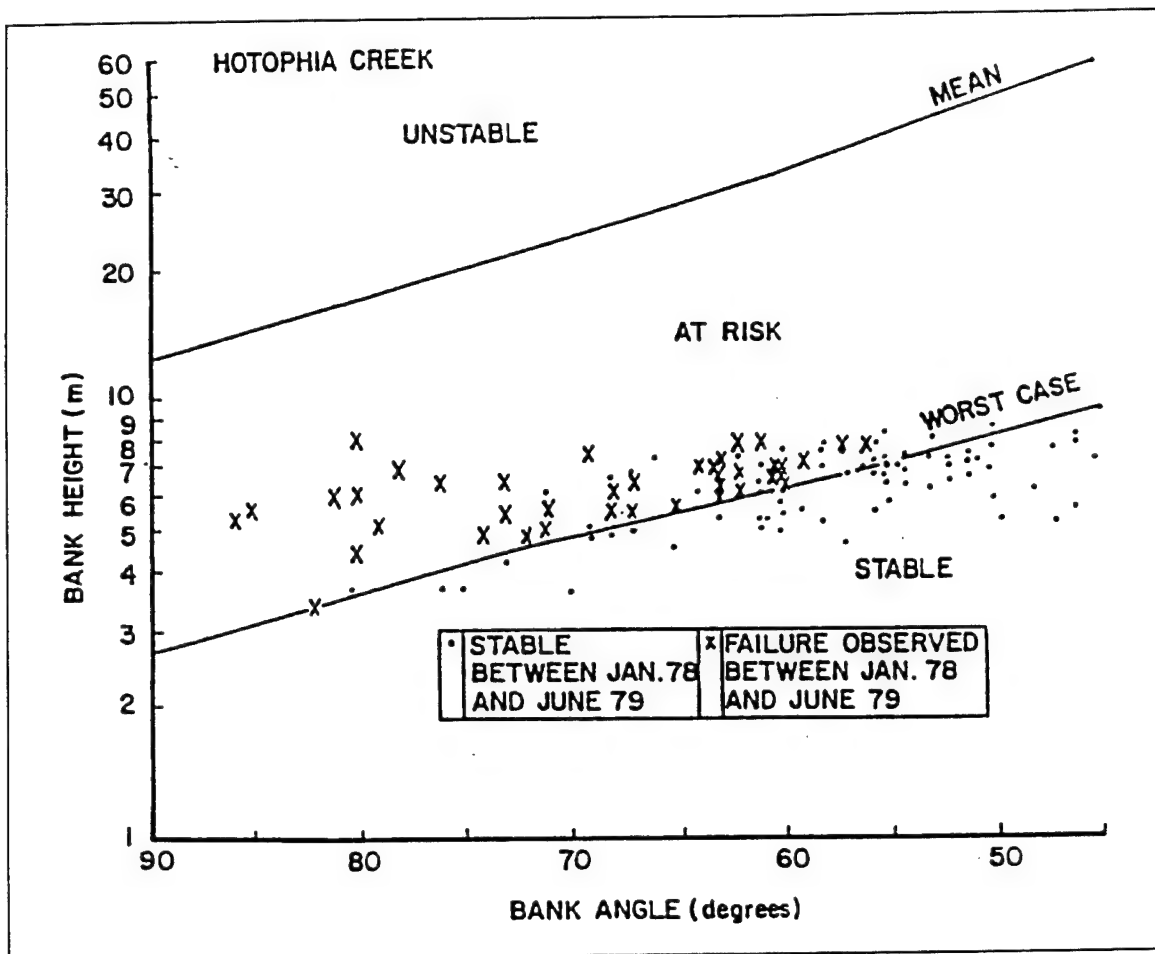
Figure 31. Bank stability graph for Hotophia Creek (Thorne, Murphey, and Little 1981)

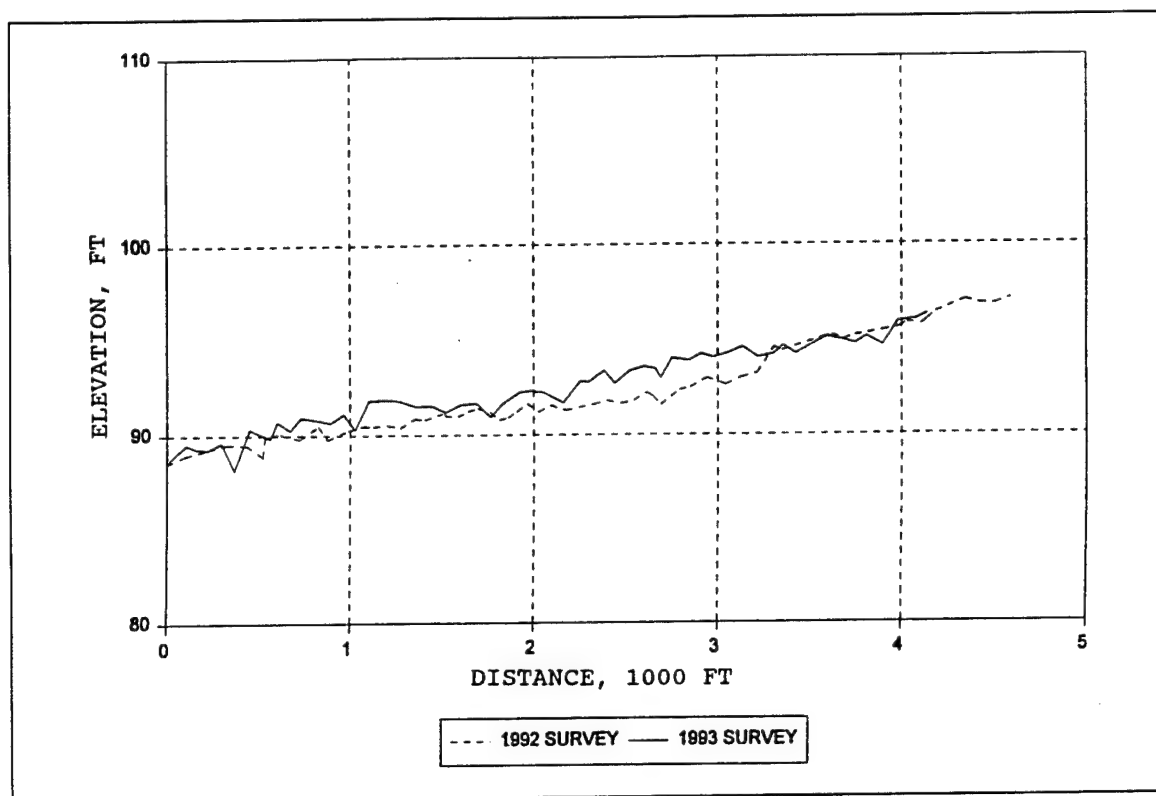
Figure 34. Comparison of 1992 and 1993 thalweg profiles for Abiaca Creek, Site 4

Site 4 extends from the confluence of Abiaca Creek and Coila Creek for approximately 4,000 ft. The upstream extent of the reach is approximately 500 ft upstream of a low timber bridge, which was apparently constructed by the local landowner or gravel miner. Depending on the amount of debris accumulation, some backwater and aggradation can exist at the bridge. Comparative thalweg profiles for Site 4 are shown in Figure 34. The surveyed thalweg slope for 1992 was 0.0017 and was 0.0016 in 1993. The 1992 thalweg indicates a break in slope approximately 3,200 ft upstream of the downstream limit, which may have been caused by debris accumulating on the low timber bridge. The 1993 thalweg indicates no break and has 2-3 ft of aggradation from 1,000 ft to 3,200 ft upstream of the beginning of the site.

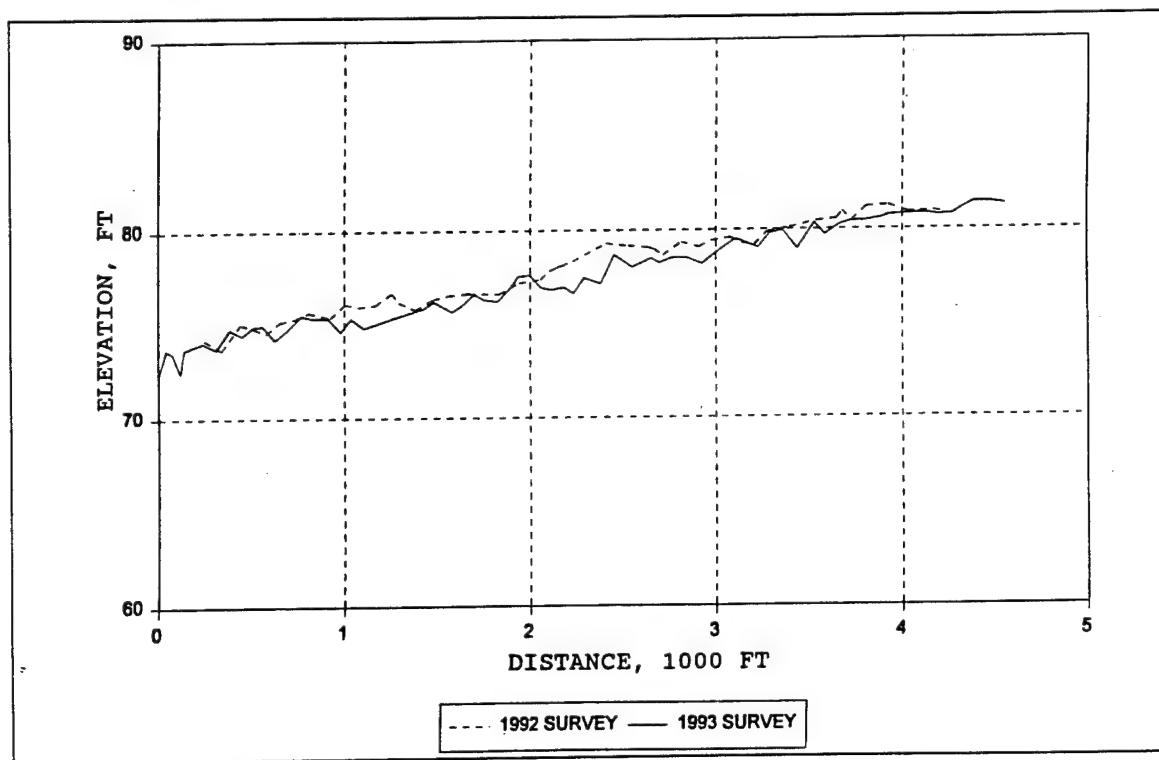
Figure 36. Comparison of 1992 and 1993 thalweg profiles for Coila Creek, Site 5

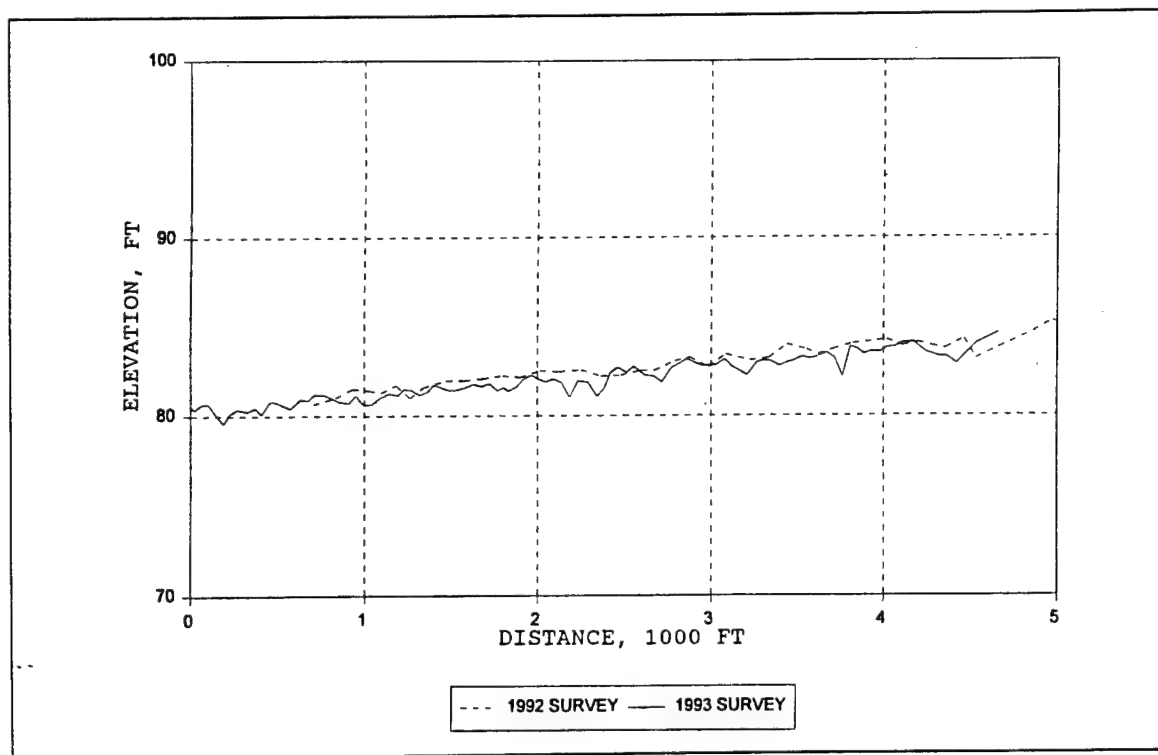
Figure 38. Comparison of 1992 and 1993 thalweg profiles for Abiaca Creek, Site 6

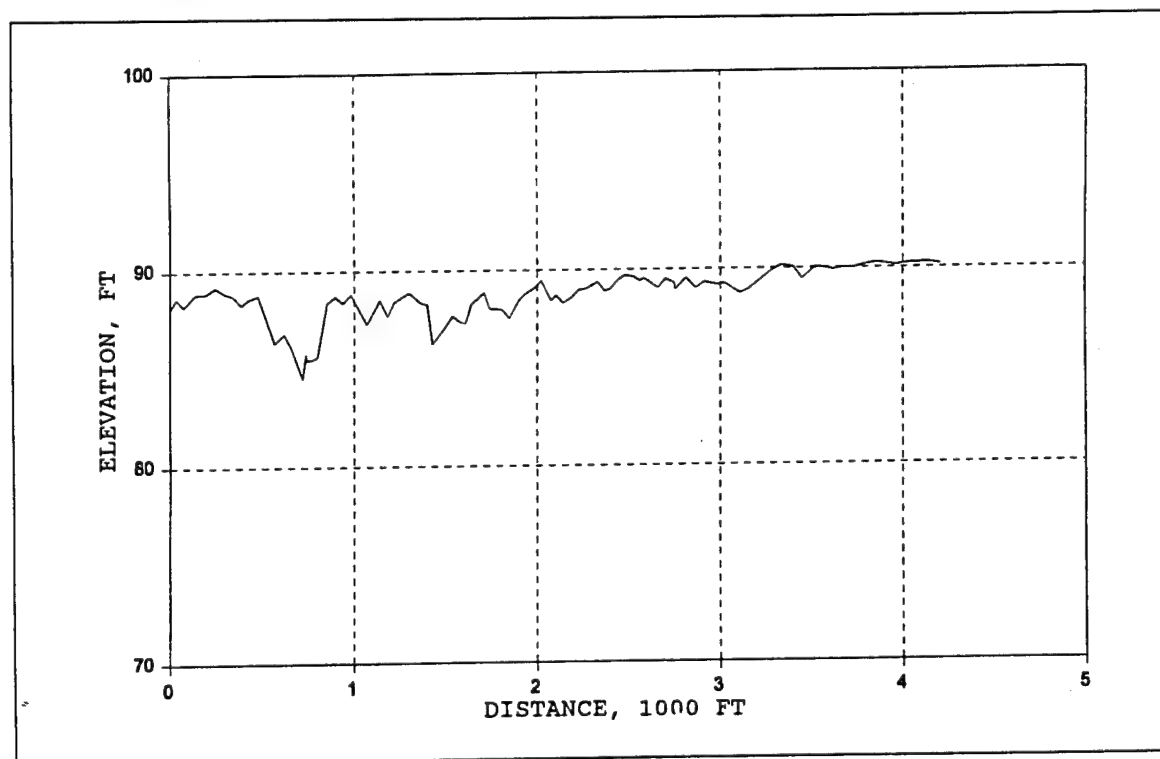
Figure 40. Thalweg profile of Abiaca Creek, Site 21, for 1993 data

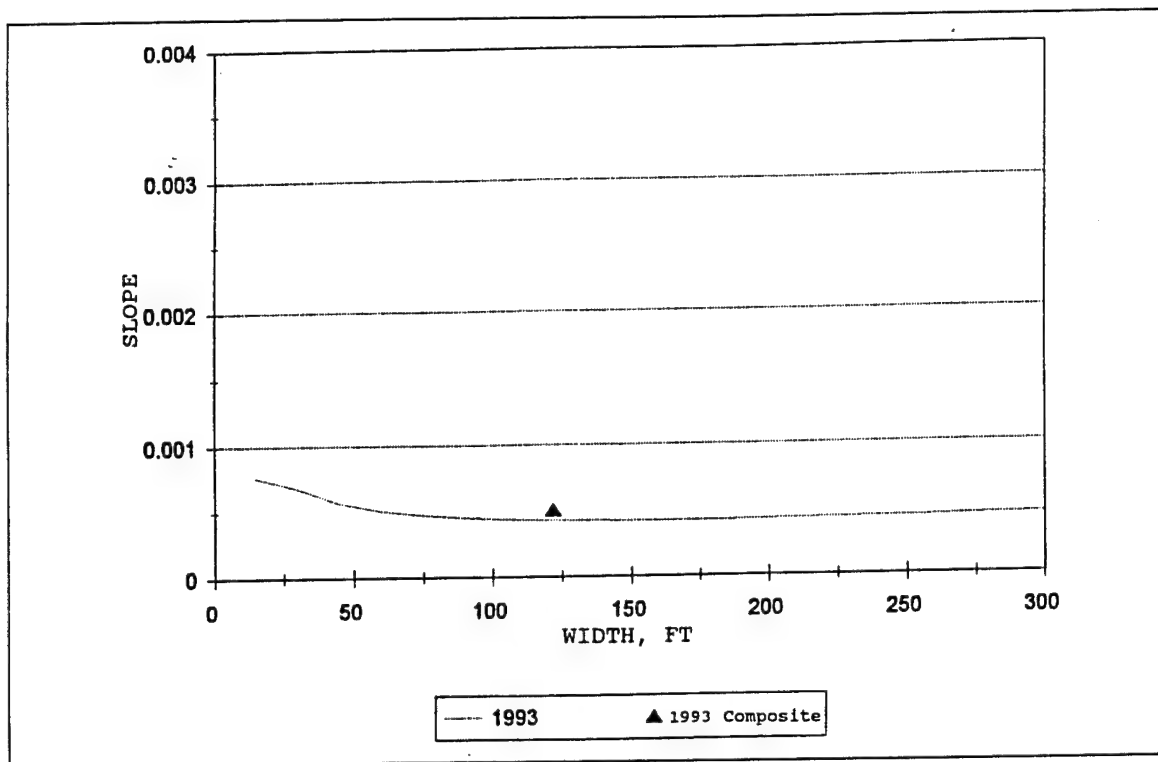
Figure 41. Comparison of computed stable channel computations for Abiaca Creek, Site 21

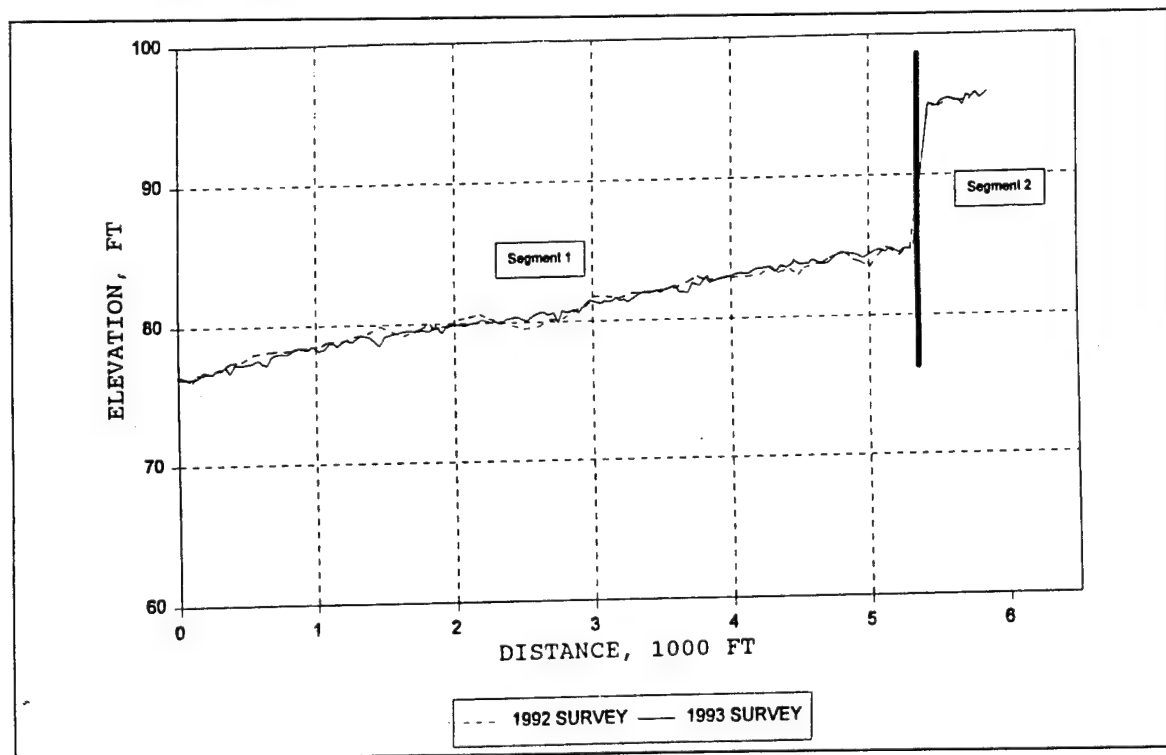
Figure 42. Comparison of 1992 and 1993 thalweg profiles for Burney Branch, Site 12

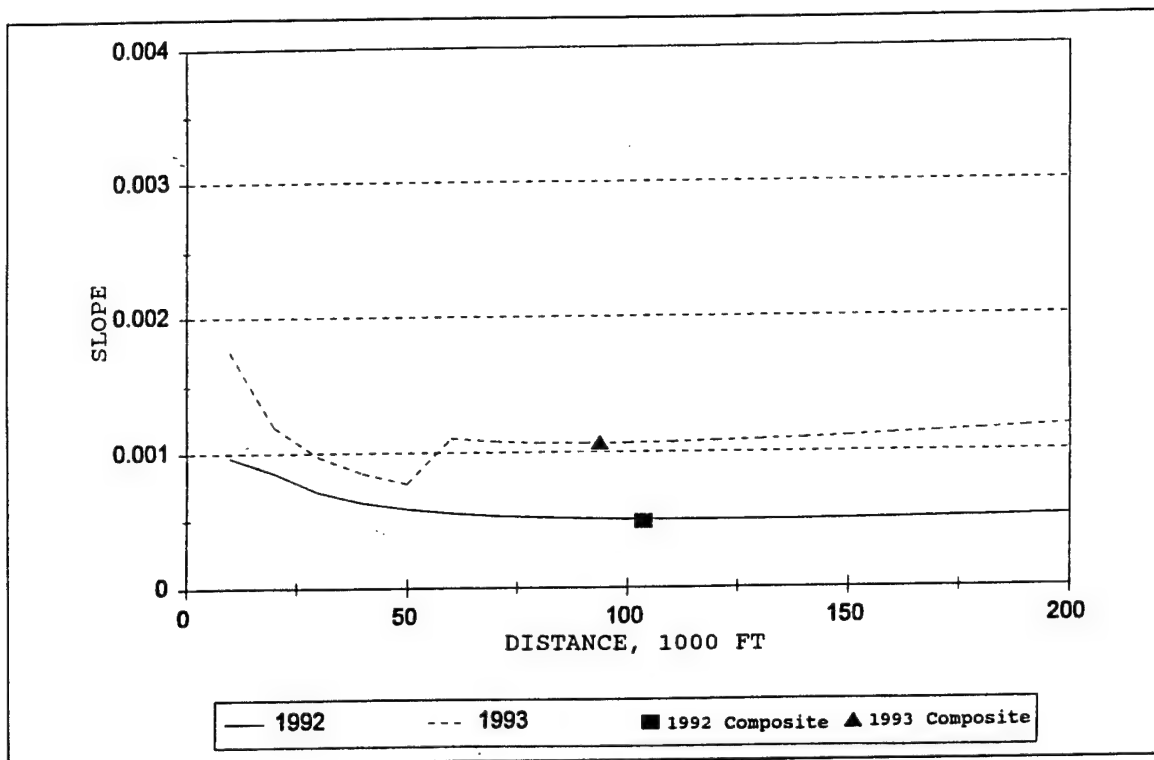
Figure 43. Comparison of 1992 and 1993 stable channel computations for Burney Branch, Site 12, segment 1

The 2-year discharge for the reach is 3,739 cfs, and the bank-full discharge was found to be 1,970 cfs, about 53 percent of the 2-year. Table 5 summarizes the analyses developed for the reach. Although the bed slope of the reach has not changed, the 1993 channel composite section was wider, slightly deeper, and about 20 percent flatter than the 1992 composite section. The 1993 section is approaching regime width and depth. The lower portion of the reach may respond to the bank stabilization by becoming deeper and narrower; however, with continued sediment supply from upstream and tributaries, the response may be masked. Computations using the Brownlie sediment transport function indicate that the bank-full sediment transport capacity decreased approximately 30 percent between the surveys. Figure 46 compares the stable channel computation results and the composite cross-section data.

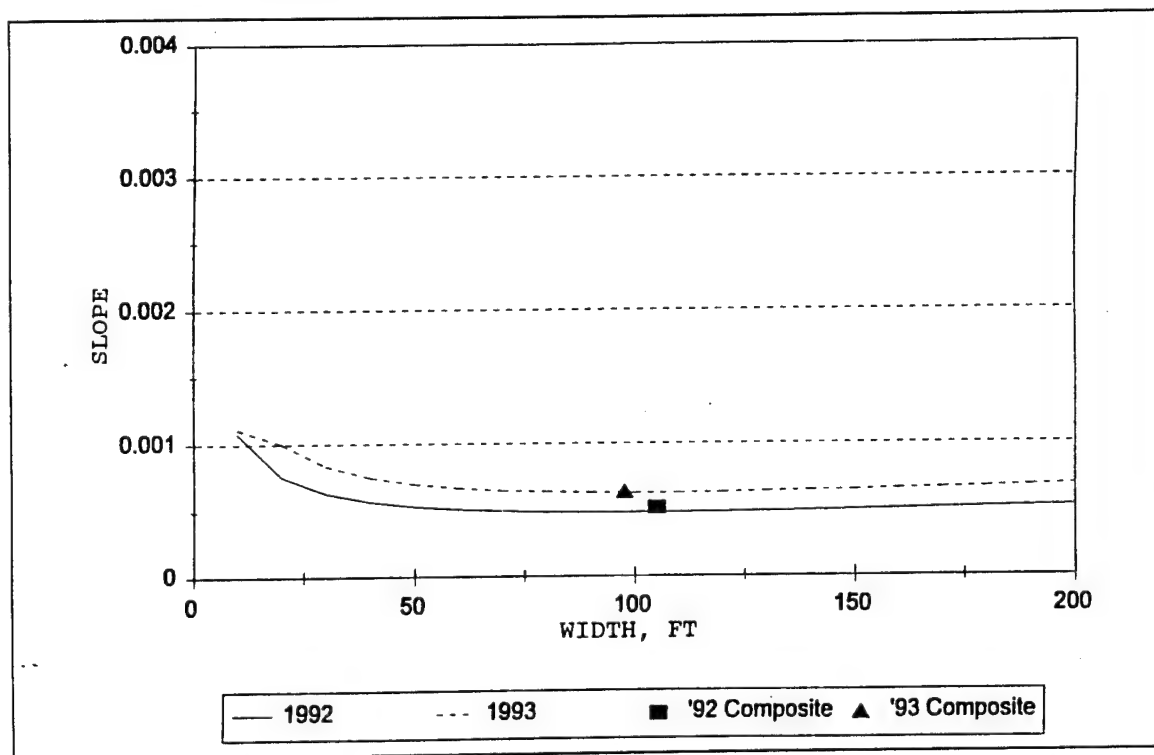
Figure 44. Comparison of 1992 and 1993 stable channel computations for Burney Branch, Site 12, segment 2

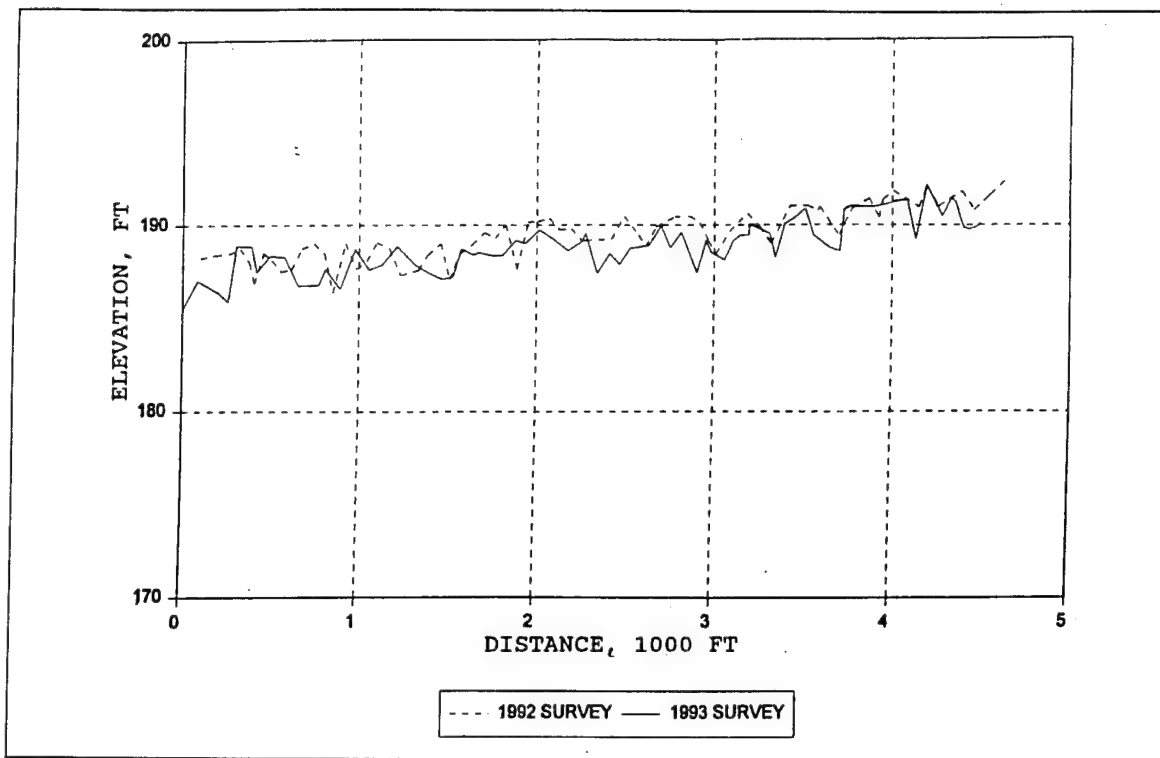
Figure 45. Comparison of 1992 and 1993 thalweg profiles for Harland Creek, Site 1

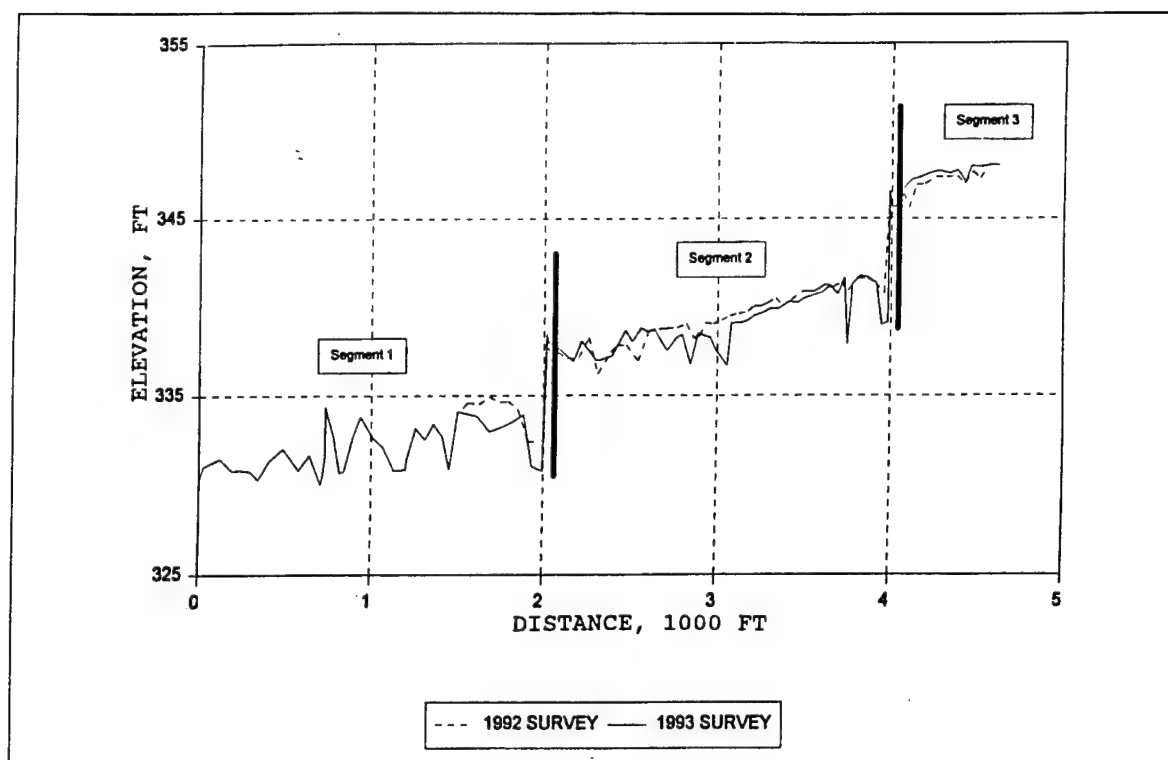
Figure 47. Comparison of 1992 and 1993 thalweg profiles for Hickahala Creek, Site 11

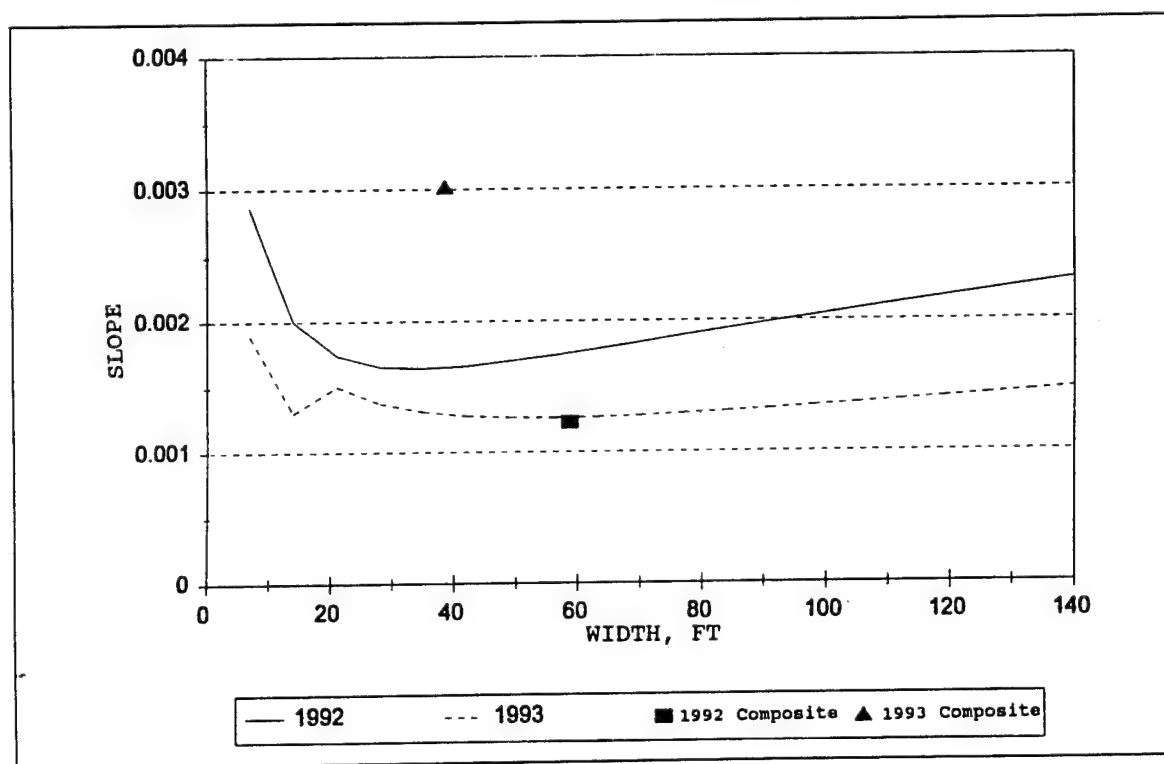
Figure 50. Hickahala Creek (Site 11), segment 3, stable channel and composite section comparison

Figures 48, 49, and 50 are comparisons of 1992 and 1993 stable channel computations and composite sections for segments 1, 2, and 3, respectively. Although the composite channel width in segment 1 is much less than the regime width, good agreement exists for the 1993 stable channel computation and the composite section. Figure 49 indicates that segment 2 is predicted to be degradational for the 1993 data, and was observed to be unstable. By comparison, the 1993 data for segment 3 is much more unstable. The channel is responding dramatically to preconstruction incision and to the structure construction. Particular attention will be paid to the segment 3 response to ascertain re-incision tendency.

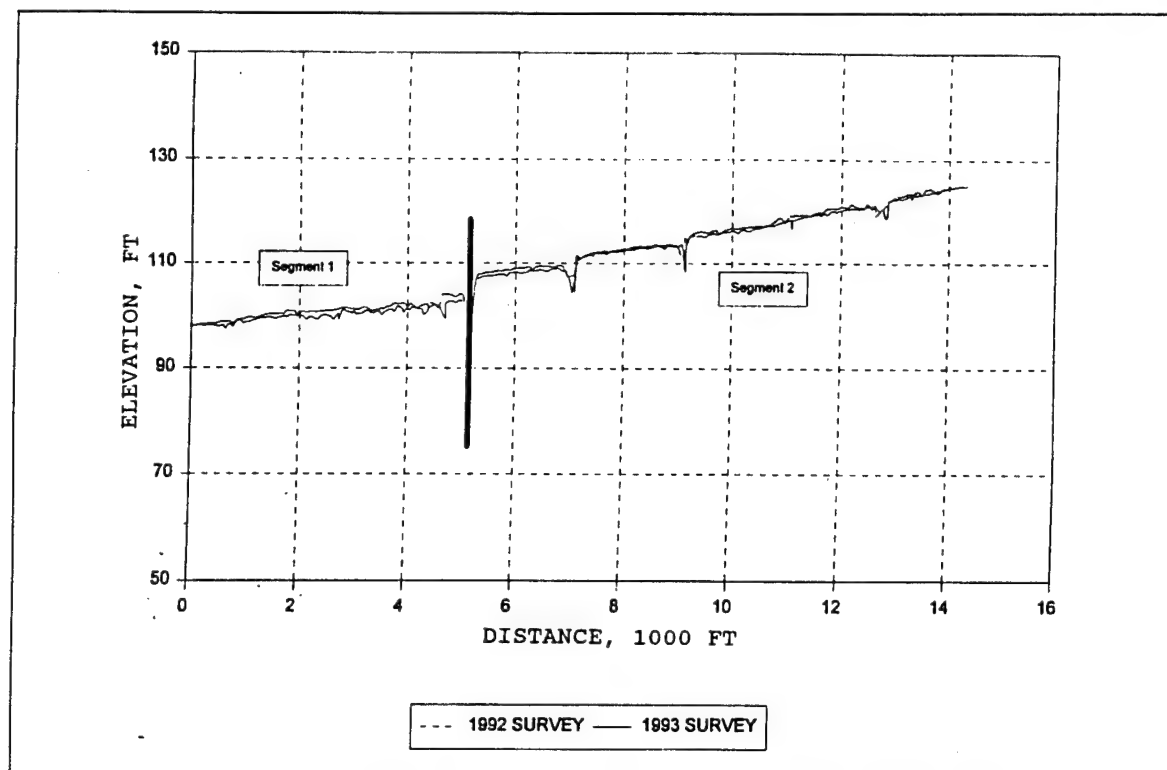
Figure 51. Comparison of 1992 and 1993 thalweg profiles for Red Banks Creek, Site 9

Red Banks Creek, Site 9, is located in the Coldwater River Basin in Watson, MS. The site extends for approximately 14,000 ft upstream of the Watson-to-Moscow Highway and is divided into two segments as shown in Figure 51. Segment 1, the downstream segment, extends from the highway bridge upstream for a distance of 5,000 ft to the most downstream of four chevron weirs constructed by the Vicksburg District. Segment 2, the upstream segment, encompasses the upstream chevron weirs and is about 9,000 ft in length. The chevron weirs are unique structures among the DEC monitoring sites, and appear to be effective in raising the bed of Red Banks Creek by aggradation. The weirs are shown in Figure 51 at locations of 5,000, 7,000, 9,000, and 13,000 ft upstream of the bridge. Most of segment 2 has a riprap toe emplaced along both banks. Segment 1 has some bank stabilization and does not have any grade control. At the bridge, a combination of low stone dikes connected at the riverward extent has worked effectively in aligning the stream with the bridge right of way and narrowing the channel. The drainage at the study site is 27.8 square miles, and the 2-year discharge is 3,951 cfs, which flows within bank. The bed slope in 1993 for segment 1 was surveyed to be 0.0009, and segment 2 was surveyed to be 0.0018. The bed material is characterized as medium sand ( $D_{50} = 0.5$  mm). The channel bed slope is relatively flat; loose sediment depth is greater than
